SUMMARY OF EVENT

The importance of managing the maintenance modification interface is fundamental to maintaining the design reliability of systems and equipment. The following diesel engine fire event will illustrate the point. The fire event occurred during a fracking operation at a well site involving multiple equipment units for hydrating, blending, and pumping. Each of these separate functions consisted of operating specialized equipment mounted on separate tractor-trailers with mounted diesel engines as main power sources. The deck engine on the in-use blender at the time was of most interest. The fire investigation origin and cause analysis showed it to be the center of the event action, i.e., the area of origin of the fire.

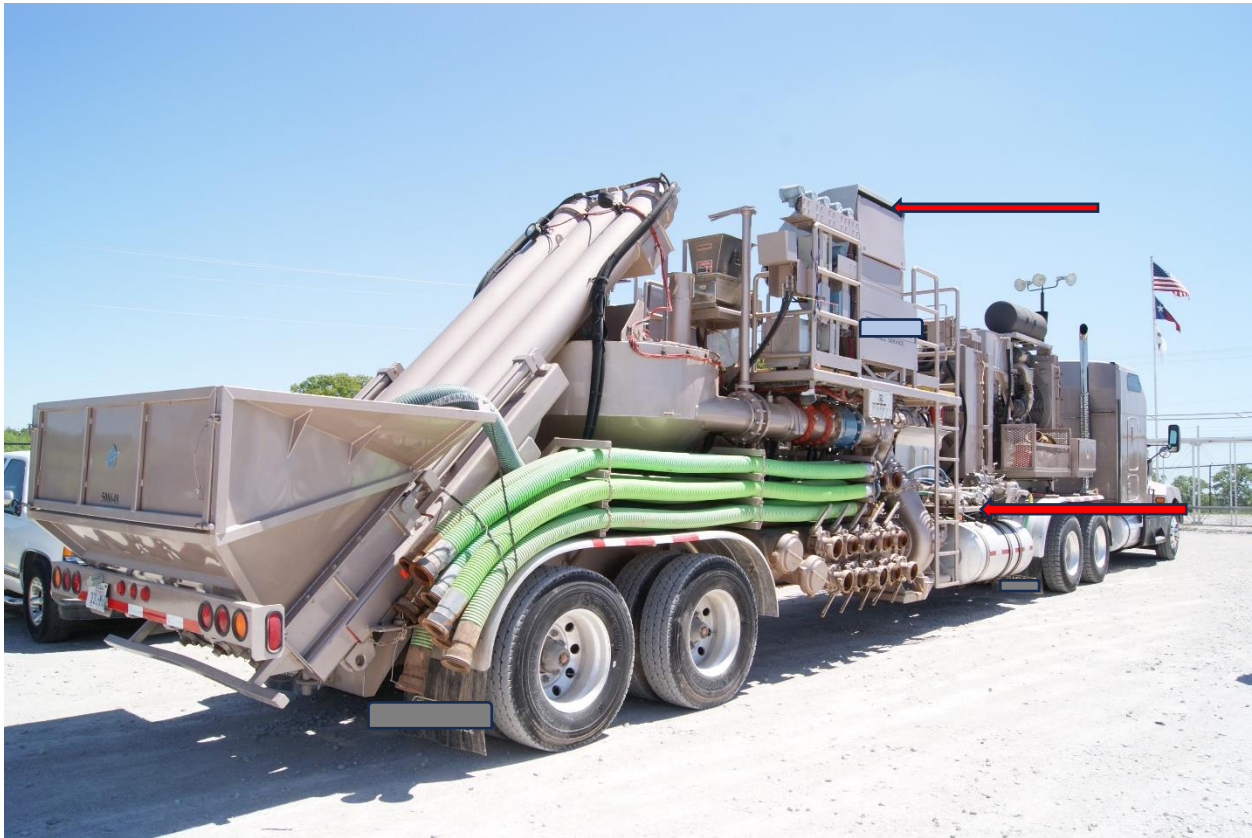
The arrows on this exemplar show the chemical addition pumps location just above the fuel tank and the blender operator's station to the left of the access ladder.

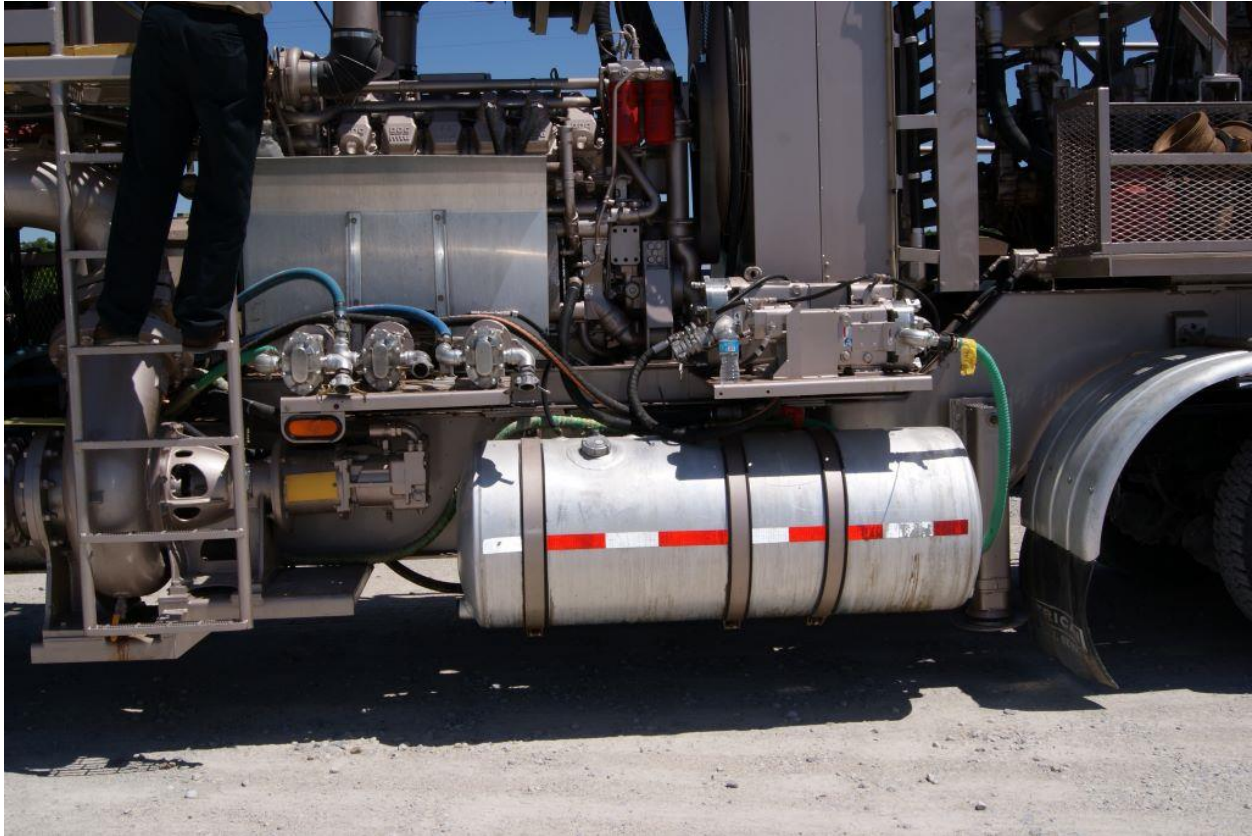
The three chemical addition pumps to the left are the pumps in the area of origin of the fire. Note the addition of a barrier to shield the pump assemblies from the exhaust manifold heat on this exemplar.

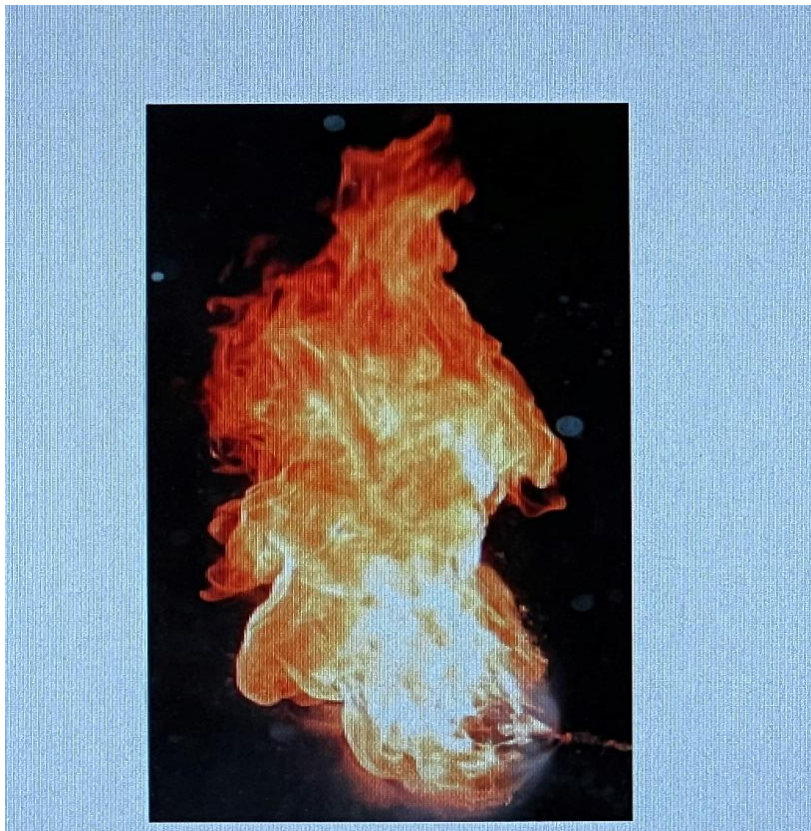
Typical hydraulic oil spray flame. Note the presence of both yellow and orange flames as observed by eyewitnesses at the fire scene. (Ref: Liming Yuan, Ignition of Hydraulic Fluid Sprays by Open Flames and Hot Surfaces, Pittsburgh Research Laboratory, NIOSH, 2006.)

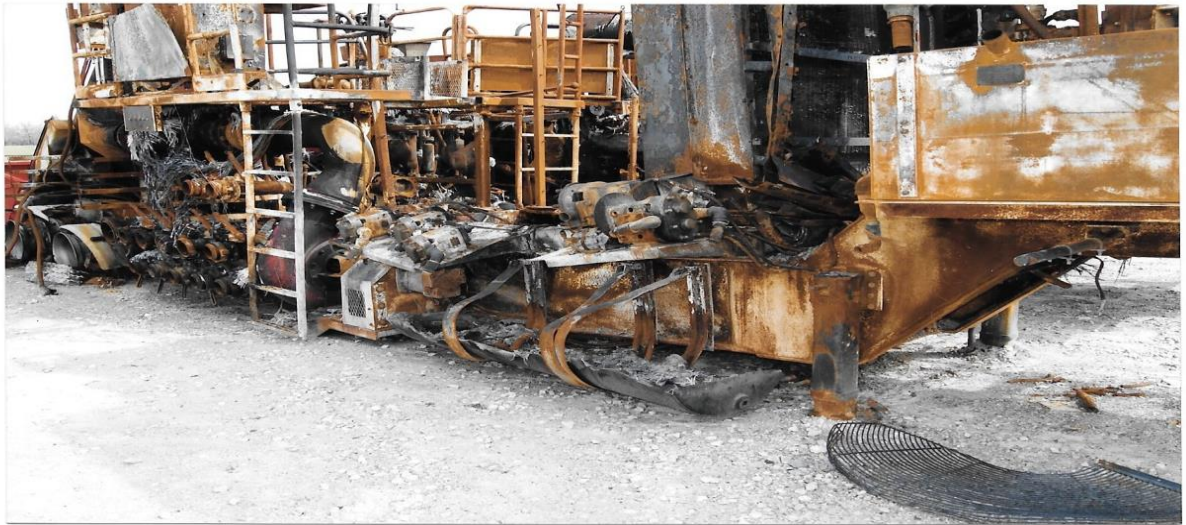
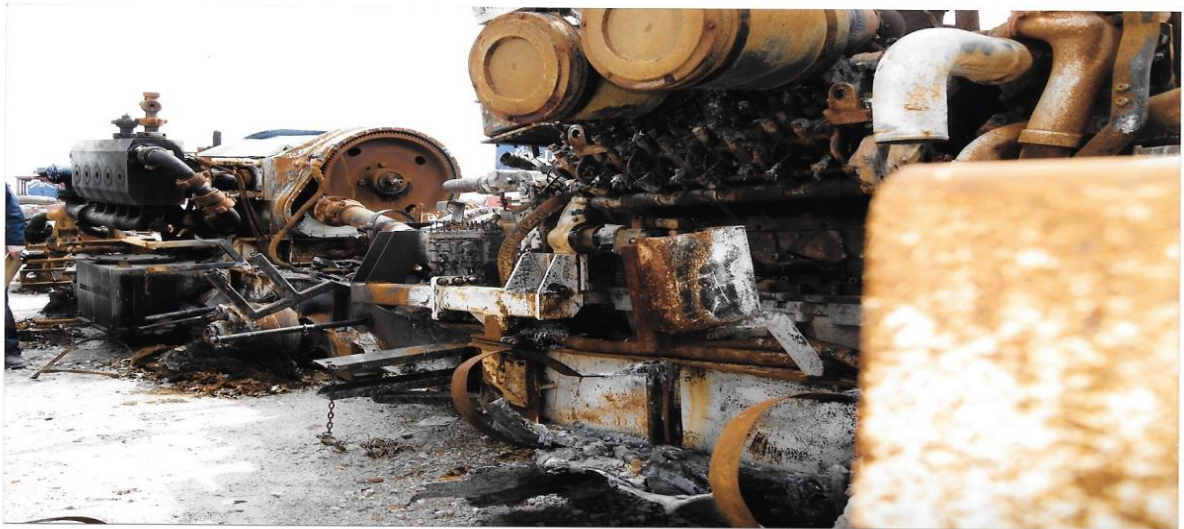
the fire on the right side of the blender unit deck engine, I concluded that a fuel source for the fire was hydraulic fluid from a failed high pressure hydraulic line or fitting on chemical addition pump #3 hydraulic motor. This failure released high pressure hydraulic fluid onto the exhaust surfaces on the right side of the engine resulting in a fire.

Destroyed blender (top photo) and high-pressure fracking pump unit. The loss for each of these units was approximately \$1,500,000 (total loss \$10,000,000).
